Project Whirlwind  
Servomechanisms Laboratory  
Massachusetts Institute of Technology  
Cambridge, Massachusetts

SUBJECT: ELECTROLYTIC CORROSION AS A POSSIBLE FUTURE SOURCE OF TROUBLE  
AFFECTING WWI RELIABILITY

Date: June 25, 1951

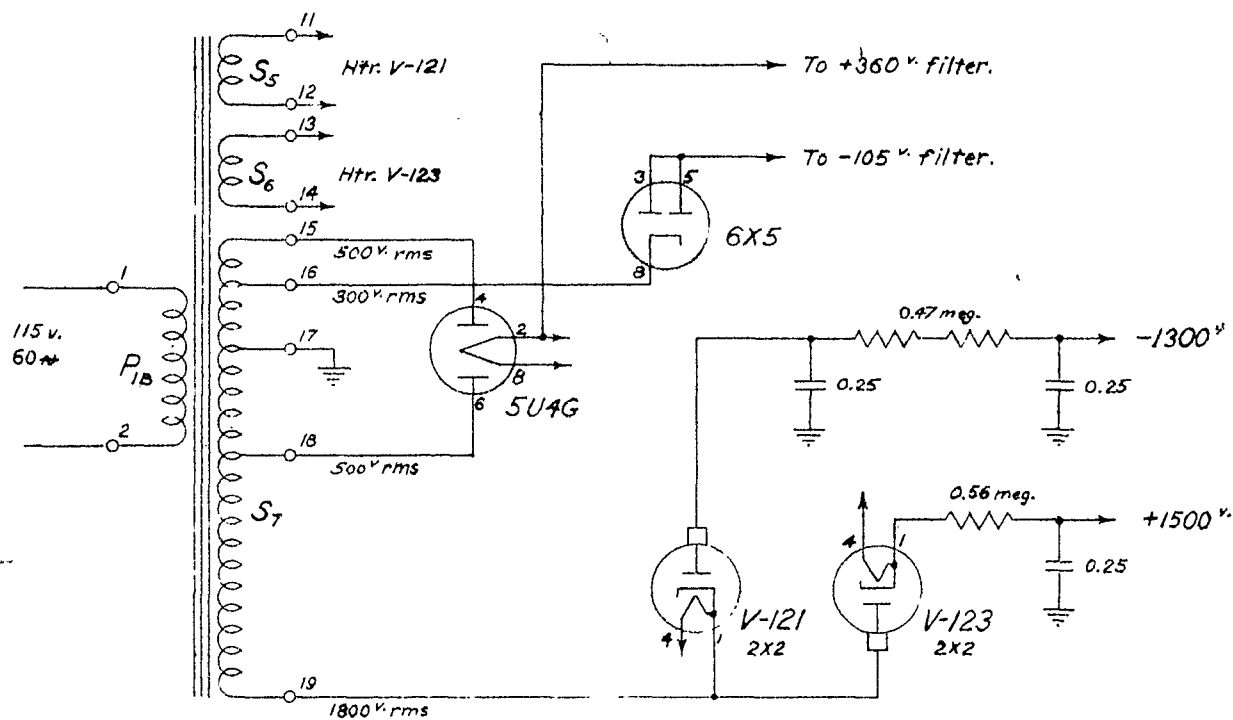
The second case, an excellent example of an advanced stage of electrolytic corrosion, came to light quite unexpectedly while the writer was disassembling a shorted high-voltage rectifier power transformer removed from a Sylvania P-5 Synchroscope. The transformer was manufactured by the Palmer Electric and Manufacturing Company, Wakefield, Massachusetts, and rectifier circuits involved are shown in Figure 1. Although breakdown of the insulation on high voltage winding S-7 was the immediate cause of failure and not electrolytic corrosion, large pits resulting from the latter were found on the underside of the entire length of filament winding S-6. This winding was at an average d-c potential of +1500 volts with respect to high-voltage winding S-7 which was immediately underneath but insulated from it by four layers of 0.012" varnished cambric followed by two layers of 0.005" kraft paper, as shown in Fig. 2. Corrosion pits were formed wherever the filament winding contacted the kraft paper.

FIG 1. P-5 SCOPE TRANSFORMER WINDINGS AND H.V. RECTIFIER CIRCUITS INVOLVED IN TYPICAL EXAMPLE OF ELECTROLYTIC CORROSION.

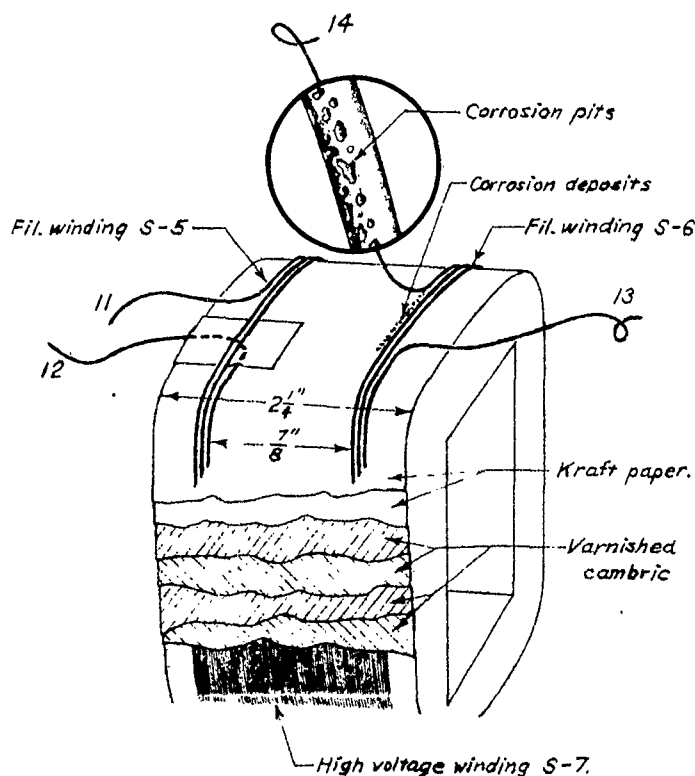
An identical filament winding (S-5) of the same wire (in all probabilities from the same original spool) wound alongside S-6 as shown, on top of the same piece of kraft paper and over the same outer layer of the high-voltage winding, showed not the slightest trace of a corrosion pit.

FIG 2. WINDING AND INSULATION DETAILS OF P-5 SCOPE TRANSFORMER.

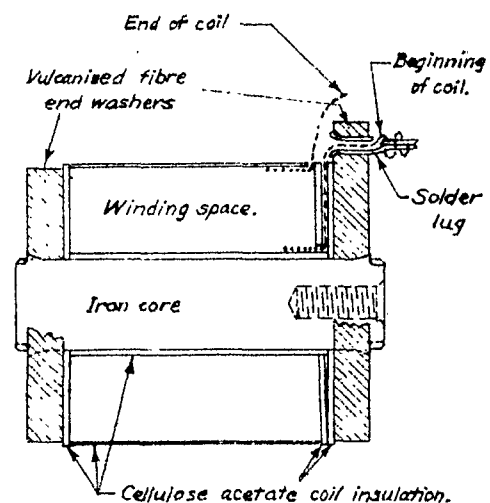
FIG 3. CORROSION-PROOF RELAY COIL WITH CELLULOSE ACETATE INSULATION.

If cellulose insulating material must be used for economical reasons, it must be protected so that the copper can never come into contact with the material itself. For example, relays such as used in the punched tape and typewriter equipment associated with WWI depend on vulcanized fibre washers staked in place for mechanical support of the fine copper wire windings of the relay coil as shown in Figure 3, page 3. A thin washer of cellulose acetate film prevents the wire from coming in contact with the fibre. The protective covering for the coil, as well as coil insulation, consists of a thin, adhesive-coated cellulose acetate film. Practically all telephone-type relays, stepping switches, and ringing mechanisms manufactured within the past ten years utilize this type of coil construction.

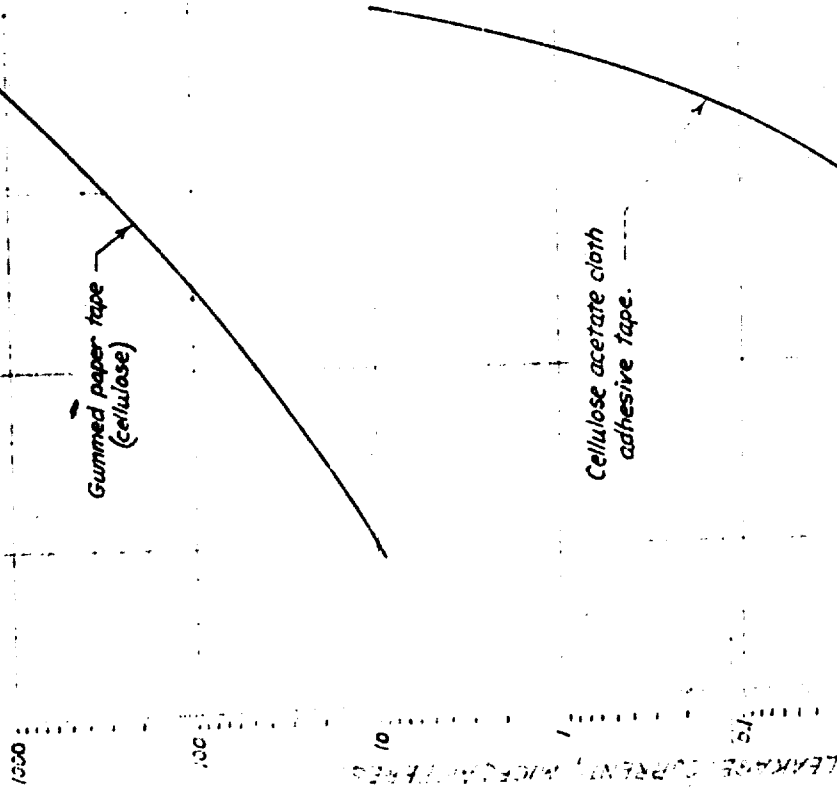
In Figure 6, a comparison of the relative leakage currents of two common insulating materials, gummed paper tape and cellulose acetate cloth adhesive tape, shows the effect of varying combinations of the aforementioned hydrolysis, leakage resistance, and moisture absorption properties. Since the individual effect of each of these properties is difficult to determine, leakage resistance is not a dependable measure of insulation quality where favorable conditions for corrosion exist.

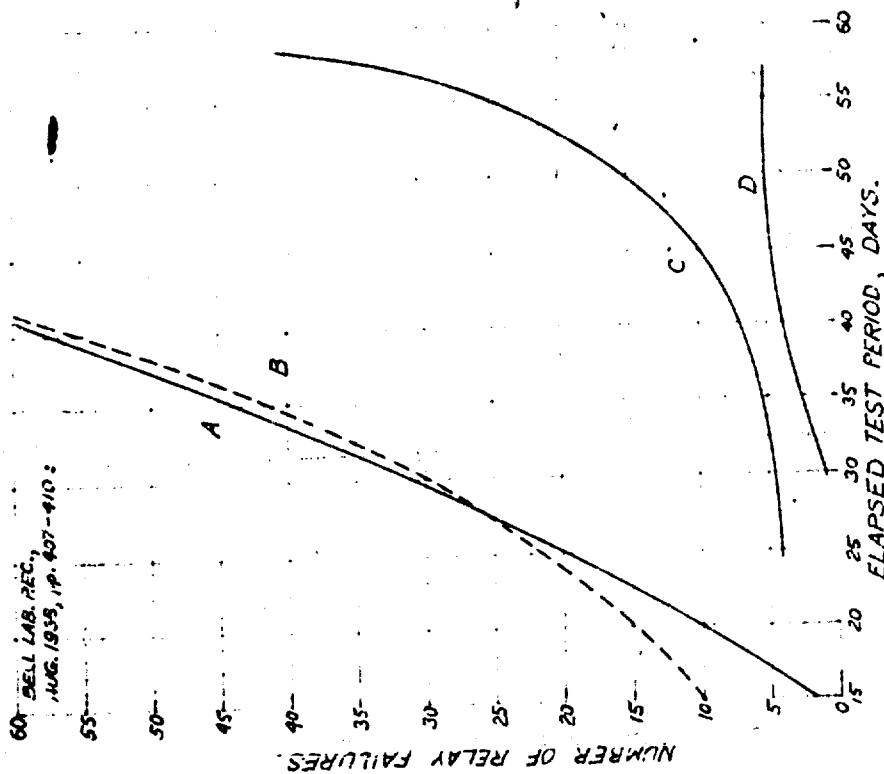
- A- Mixed paper core cover, interwinding insulation, and outer action yam sewing.
- B- Same, but impregnated.
- C- Cellulose acetate yarn core and coil covers, stored paper interwinding insulation.
- D- All coil insulation of cellulose acetate sheet.

FIG. 7. EFFECT OF HUMIDITY ON LIFE EXPECTANCY OF RELAY.

Obviously, if all cellulose-based insulating materials and adhesives containing glue or other hydrolyzing substances are eliminated from relay coils of fine wire energized for long periods of time at positive d-c potentials, relay life expectancy is without limit where corrosion elimination is concerned, as shown in Figure 7, page 9.
